# FULDSKALA DEMONSTRATION AF TERMOAKTIVE KONSTRUKTIONER

BILAGSRAPPORT

**Yearly indoor comfort evaluation and energy consumption, and assessment of  
thermal activated building systems in Middelfart Sparekasse.**

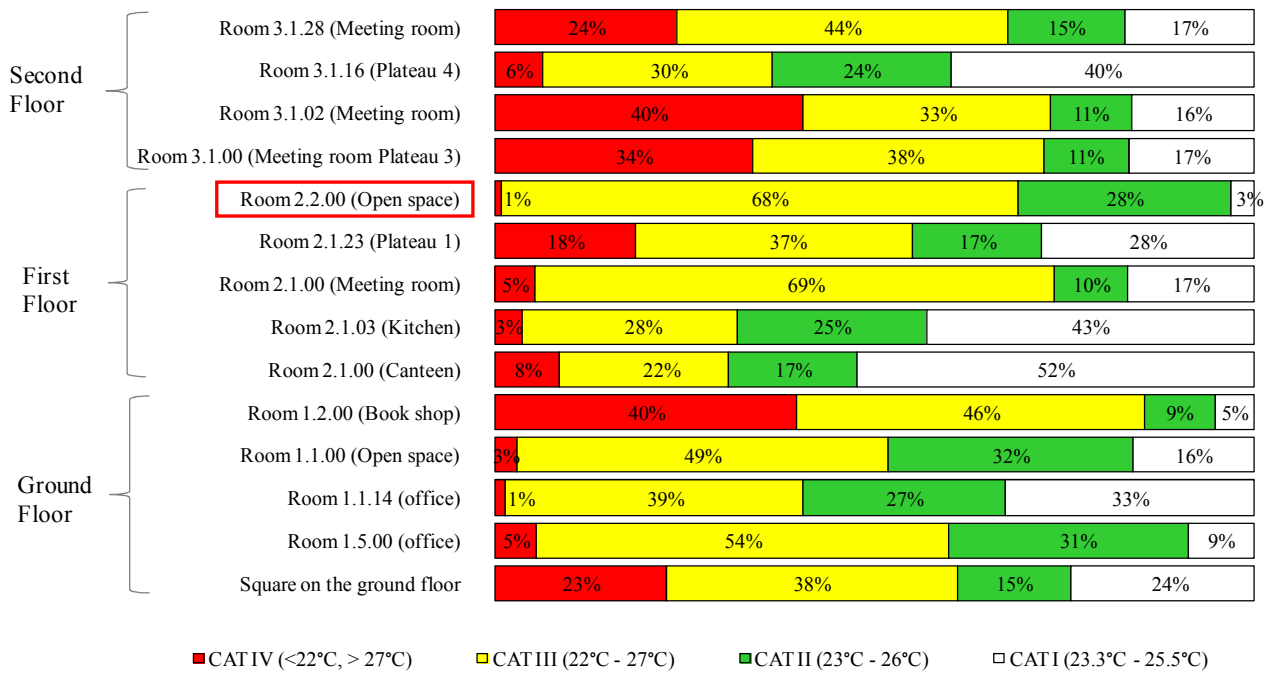
Figure 8a– Thermal quality evaluation of all the monitored rooms during the summer period.

Figure 7 and figure 8 show respectively the thermal and air quality evaluation for winter and summer periods. The winter period went from November 2010 to march 2011, while the summer period went from April to September 2011.

the temperatures were in category IV. The worst results are in the meeting rooms, were usually there were not constant heating loads and so the temperatures were lower than in other cases. These meeting rooms, in particular the two analyzed at the second floor, were conditioned just by the mechanical ventilation system.

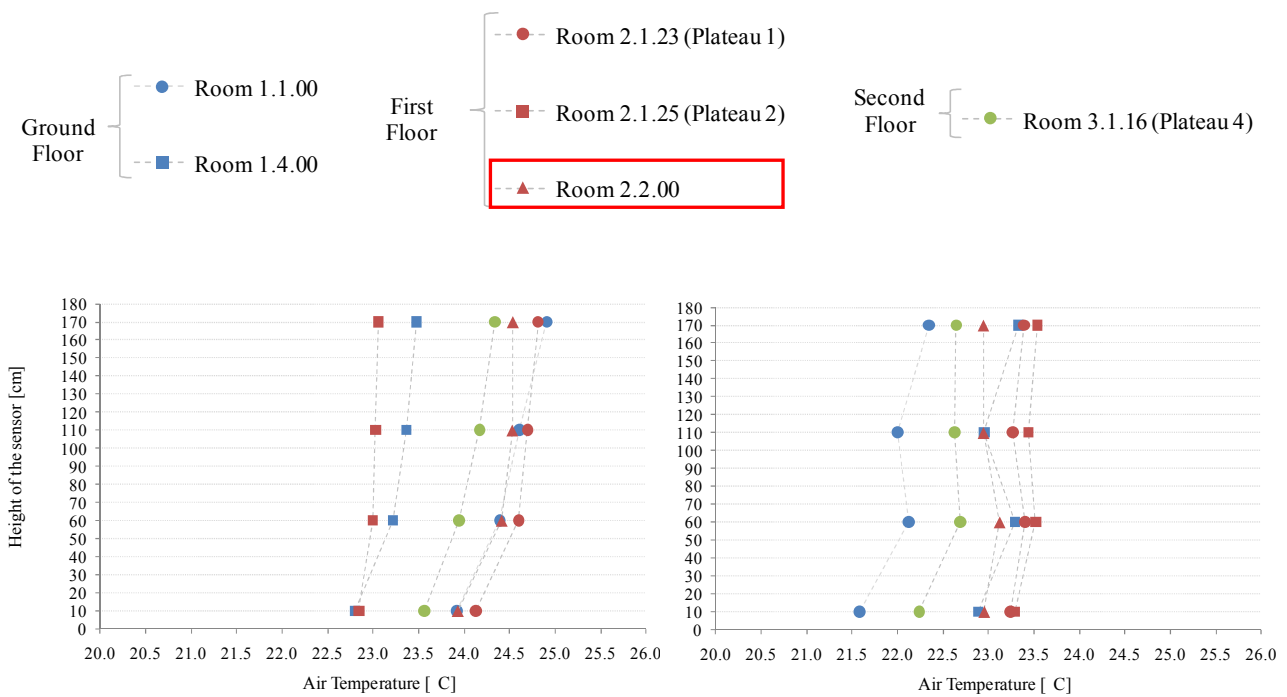
Figure 12a - Average value of Air Temperature [°C] at different heights in the analyzed rooms. Winter and Summer
