Pilot project at Coloplast testing Daylight Redirecting Glass Lamellas

The Coloplast premises

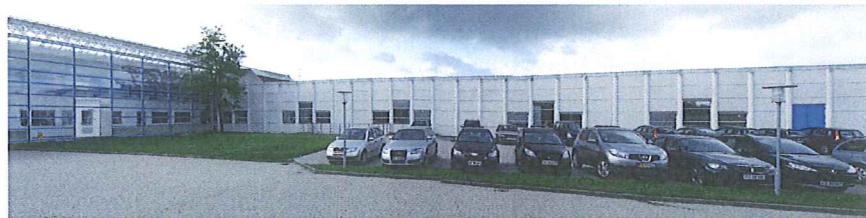
The Coloplast premises are situated at 56.96°N, 12.49°E north of Copenhagen, Denmark. The office building used for the pilot project is lying opposite two other buildings. Right in front is another office building, to the left a glass clad corridor building connecting the two buildings, see figure 1.

Figure 1. The office building used for the pilot project is lying opposite two other buildings.

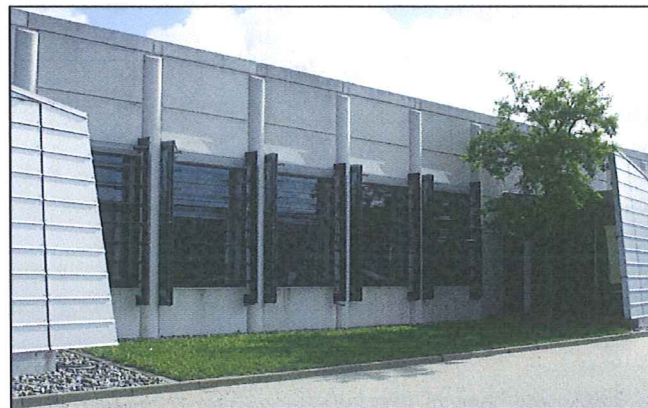
The daylight redirecting glass lamellas are mounted outside one office module (the Test area) and the existing sun shading glass lamellas are mounted outside an adjacent office module (the Reference area), see figure 2 and 3.

Figure 2. Façade of test area.

- At the façade of the test area, see figure 2, noticeable bright spots are visible above the windows. It might indicate that a repositioning of the lamellas is necessary in future installations.

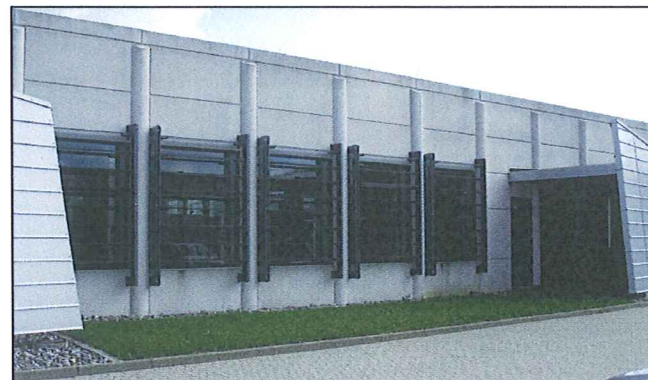
Figure 3. Façade of reference area.

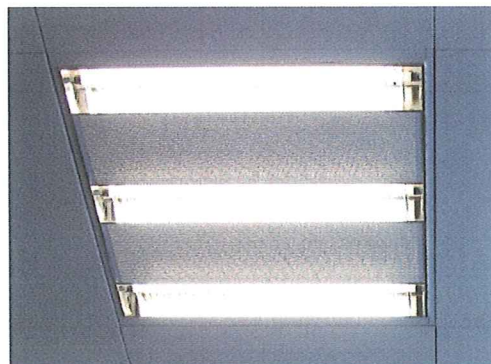
Luminaries were built into the ceiling in a regular pattern throughout the offices, see figure 5.

Figure 5. Built-in luminaries in the offices.

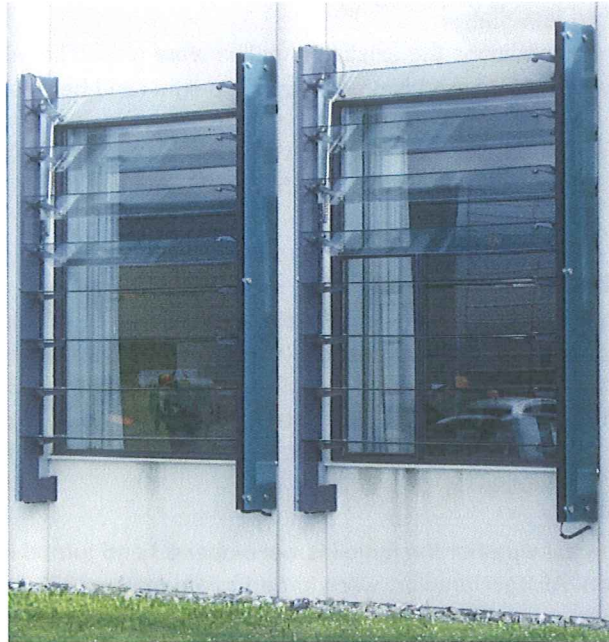
In the test area the top four existing sun shading glass lamellas were replaced by daylight redirecting glass lamellas. The new lamellas are produced by Saint Gobain Glass type Antelio Silver with a light reflection of 31%. The existing lamellas are also produced by Saint Gobain and are of type Parasol Green with a light reflection of 6% and with white frit covering 55% of the surface. Optical properties for both glass types are described in paragraph The shading system*. The facades of the test and reference areas are shown in figures 7 and 8.

Figure 7. Close-up of glass lamellas in test area. The top four lamellas are made of Antelio Silver glass 10 mm thickness.

The top four lamellas in the test area are operated by their own motor and will be adjusted according to a set of weather parameters independent of the behavior of the existing lamellas. Parameters for the new lamellas are described in paragraph The shading system*

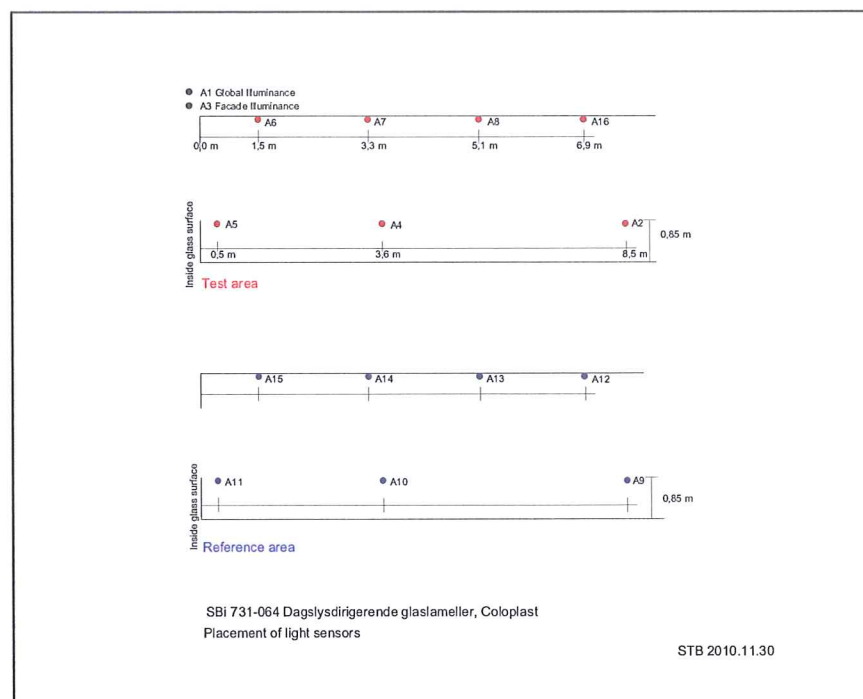
The sensors were placed at a height of 0.85 m above the floor and mounted at the ceiling, see figure 10.

Figure 10. Placement of illuminance sensors 0.85 m above the floor and at the ceiling in test and reference areas.

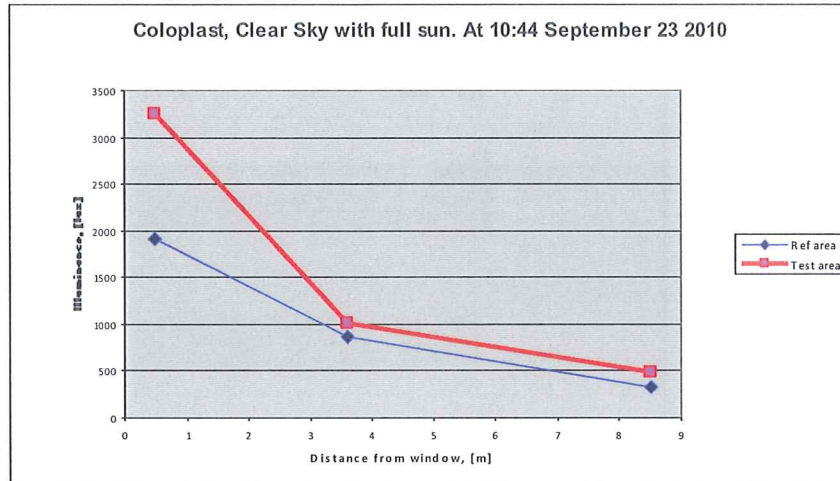
For clear sky conditions a rise in illuminance levels in the test area are seen compared to the reference area throughout the day, see tables 1 – 3 and figures 11 – 13. The illuminance is largest at the window position decreasing in through the room. At a distance of 8.5 m (furthest back in the office) the illuminance levels are 489 lux against 331 lux (morning), 488 lux against 429 lux (noon) and 366 lux against 260 lux (afternoon).

Figure 11. Illuminance level at workplane, clear sky, 10:44 September 23 2010, morning.

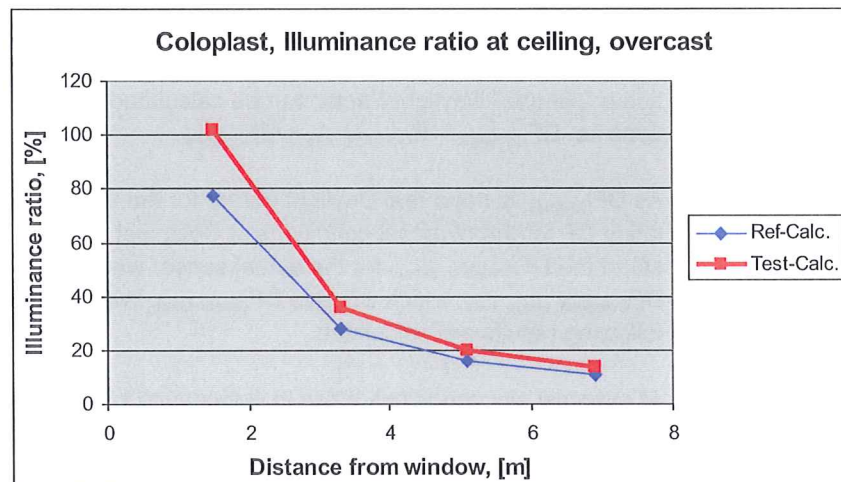
At overcast sky conditions a rise in illuminance levels in the test area compared to the reference area are seen, see tables 4 – 5 and figures 14 – 15. The $DF_{sensor rated}$ is largest at the window position decreasing in through the room. At the workplane and at a distance of 8.5 m the $DF_{sensor rated}$ are 10 against 7. At the ceiling and at a distance of 6.9 m the $DF_{sensor rated}$ are 13 against 10.

Figure 15. Illuminance ratios at ceiling, overcast condition.
